## INTERSTATE COMMERCE COMMISSION.

REPORT OF THE CHIEF OF THE DIVISION OF SAFETY, COVERING THE INVESTIGATION OF AN ACCIDENT WHICH OCCURRED ON THE BALTIMORE & OHIO RAILROAD NEAR WOODLYN, PA., ON SEPTEMBER 19, 1914.

DECEMBER 23, 1914.

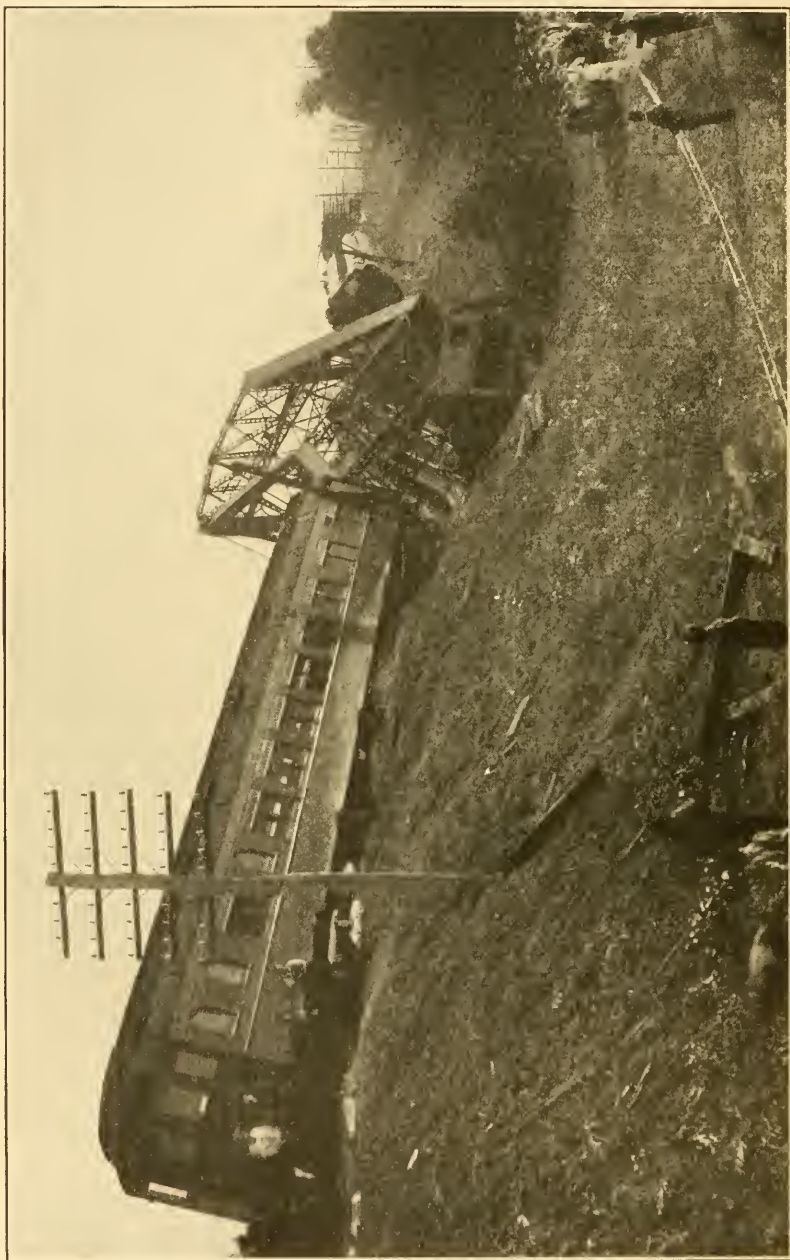
No 1.—General view of the derailment looking south.

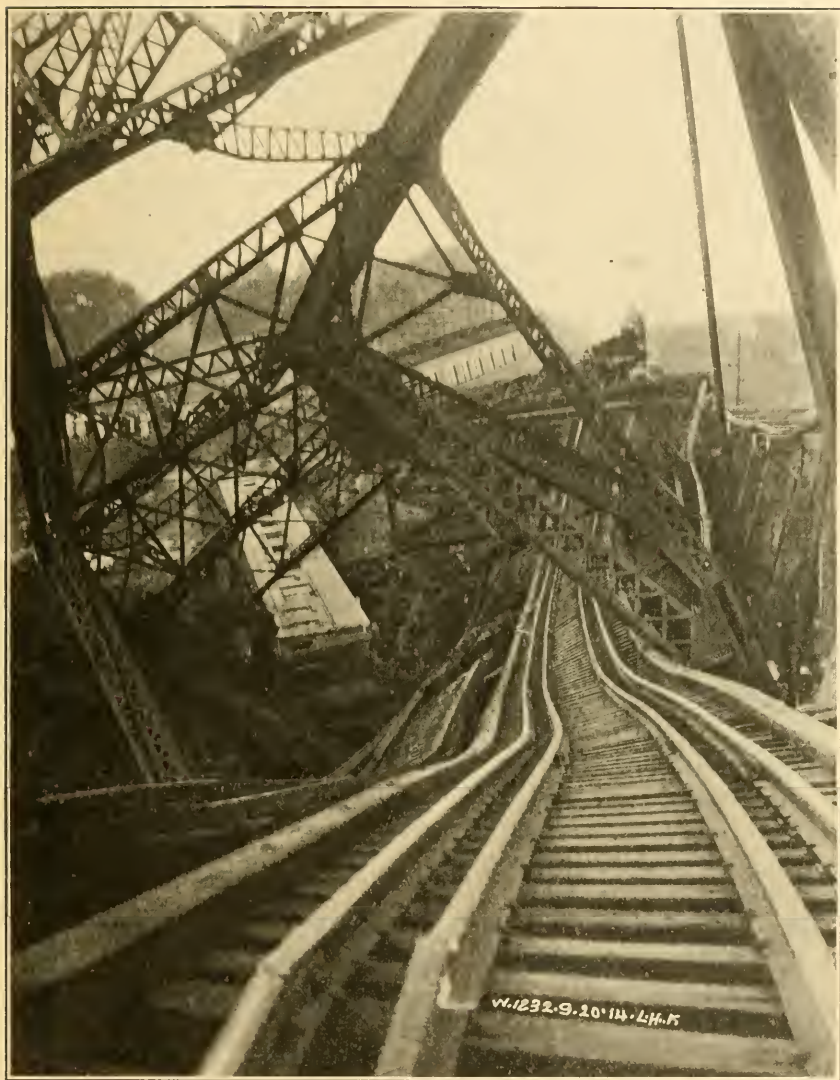
No. 2.—View of wrecked bridge looking north, showing steel car on its side at foot of embankment.

the right enough to strike the end post of the right-hand truss of the bridge, after which it plunged to the track below, a distance of about 25 feet. The second Pullman sleeping car stopped with its forward end projecting over the bridge abutment and was also leaning to the right against a telegraph pole. The last car in the train, a parlor car, was also derailed, but remained upright at the top of the embankment, immediately behind the second sleeping car. The damage caused to the bridge by the sleeping car *Rachita* caused its collapse. Illustration No. 1 is a general view of the accident, looking in the direction in which the train was moving. Illustration No. 2 is a view looking in the opposite direction and shows in particular the condition of the bridge after the accident.

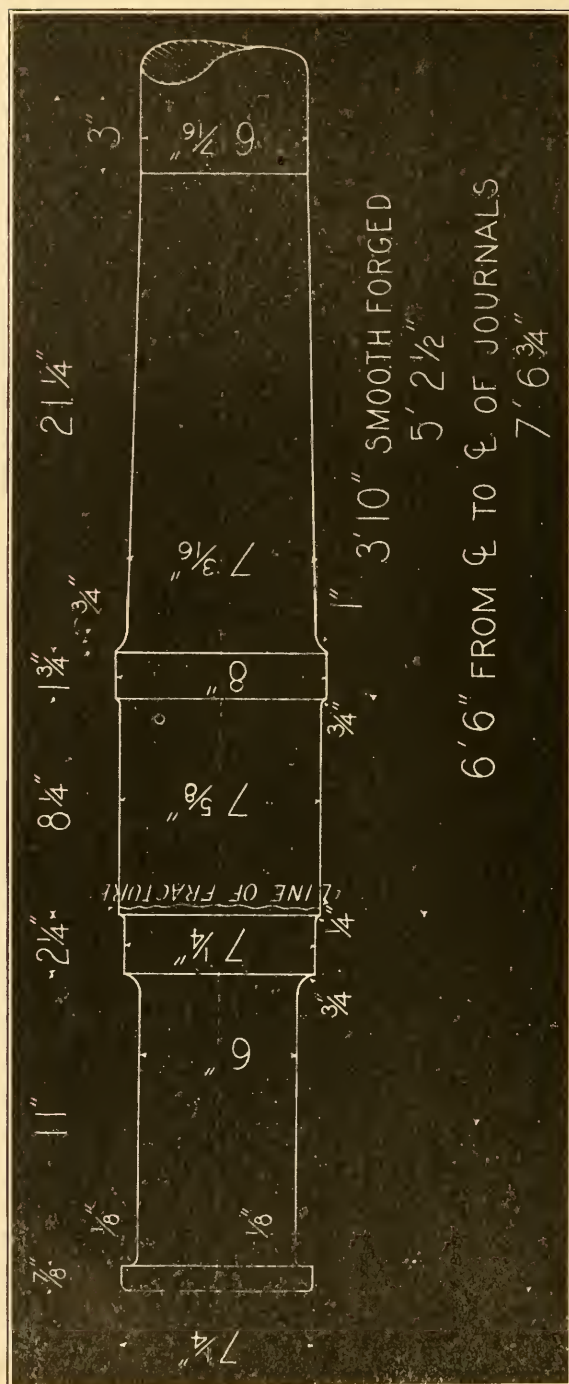
No. 3.—Sketch showing dimensions of fractured tender axle, with line of fracture indicated thereon.

This axle fractured at a place where the bending stresses were not at their maximum, a circumstance which calls for special inquiry. The fracture did not occur at the face of the hub of the wheel, but at a distance within, ranging from three-sixteenths of an inch to seven-sixteenths. From its position it was effectually concealed by the metal of the hub, its presence not admitting of discovery prior to the complete separation of the metal and the failure of the axle. The type of fracture, however, was a common one, and known as a detailed or progressive fracture. A type of fracture which results from a number of repetitions of load. Fractures of this kind are unaccompanied by the development of ductility which is displayed in the usual tests of the metal.

That the fracture of the axle occurred on the wheel fit, at a place some three-sixteenths to seven-sixteenths inch within the section covered by the hub of the wheel.

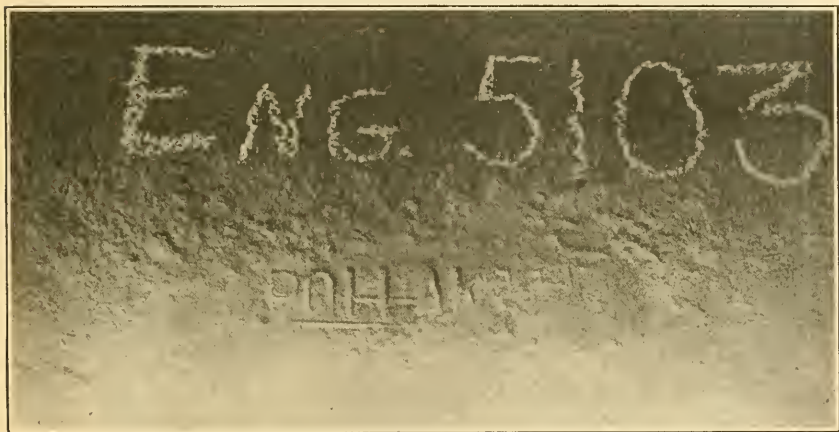
No. 4.—Brand mark "Pollak" on axle at middle of length.

The records of the Baldwin Locomotive Works do not furnish any information upon this feature of the case. In fact, their records do not show that a Pollak axle was used, but on the other hand they call for a Carnegie axle in its place. Carnegie axles were inspected and accepted by the Baltimore & Ohio Railroad Co. for this tender, but the presence of the brand mark "Pollak" and the initials of the Baldwin Locomotive Works, with the date of pressing on the wheels

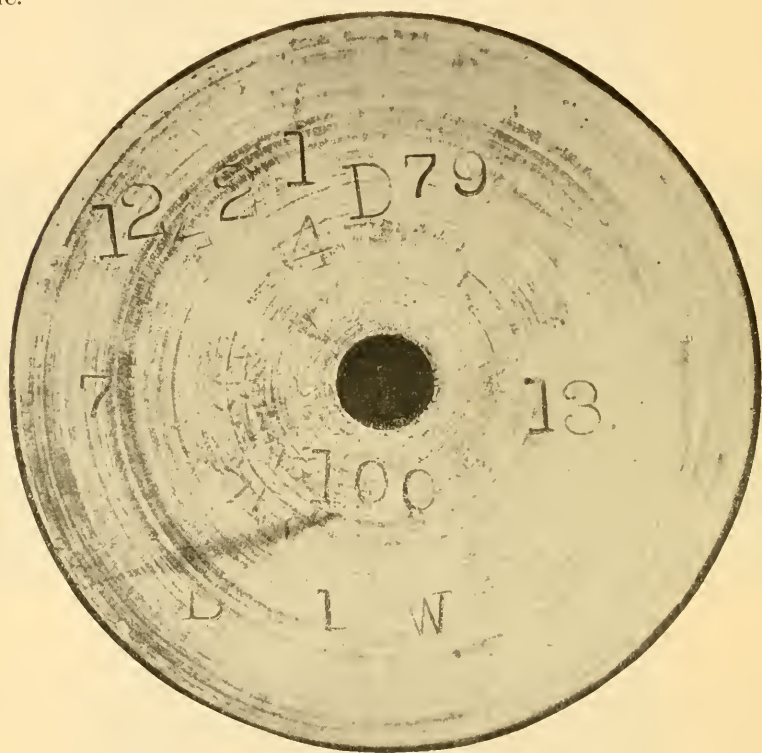
This axle bore the brand mark "Pollak," of the Pollak Steel Co., at the middle of its length. It was finished and assembled by the Baldwin Locomotive Works. The ends of the journals were stamped "7 13 100 B L W." and "7 13 80 B L W." on the fractured and intact ends, respectively. These marks indicate that the wheels were pressed on the axle at the Baldwin Locomotive Works in the month of July, 1913, and that a pressure of 100 tons was used for the wheel at the fractured end and 80 tons for the opposite wheel.

No. 5.—Marks stamped on end of fractured journal 7 13 100 B L W, indicating date wheel was pressed on axle and pressure, in tons, used.

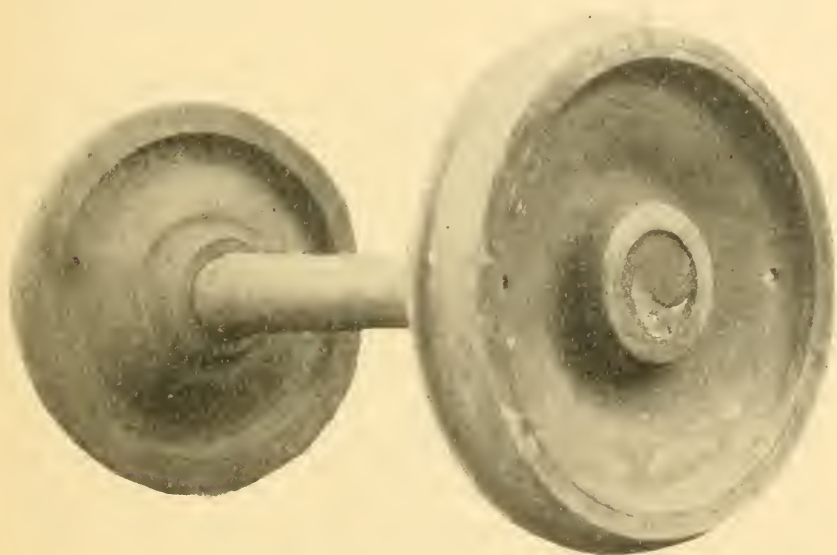
No. 6.—Truck wheels, showing fractured surface of axle just below face of hub.

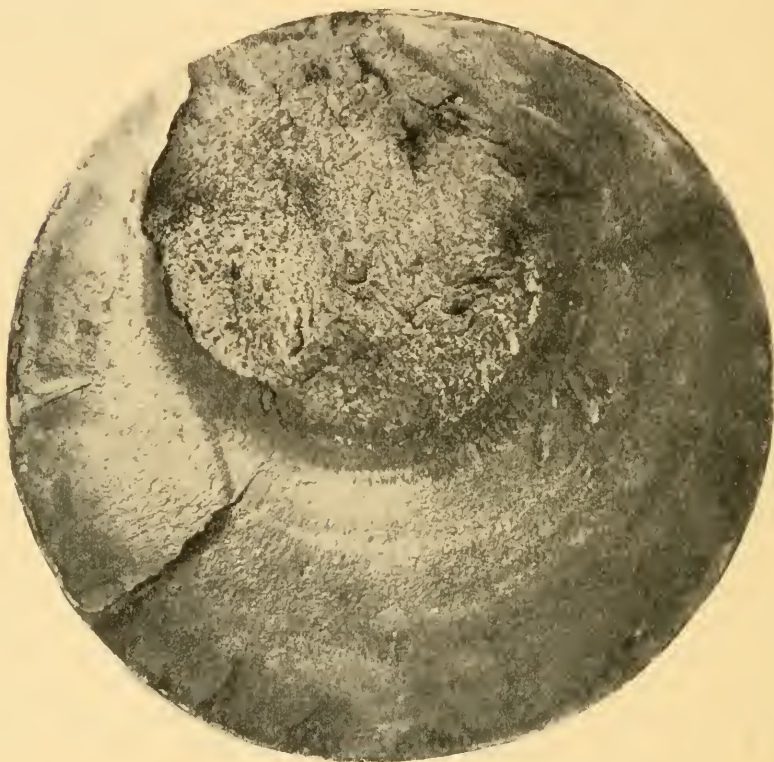
The fracture of this axle started on one side of its cross section, thence extending toward the center. At the time of final rupture only about one-quarter of the cross section remained intact. The final portion was an eccentric section some 3 inches in diameter. The fractured surface presented the usual characteristics witnessed in repeated stress fractures. The earlier fractured portions were hammered smooth by the longitudinal compressive component, which acted on the axle up to the time of final fracture. The portion which failed last had a silky appearance, but was somewhat battered by blows received at the time of the derailment. The fiber stresses in this part of the axle certainly were greatly augmented before final rupture was reached. They must have been increased several fold at the time the axle was reduced to an effective diameter of 3 inches.

No. 7.—End view of fractured axle, showing character of surface of progressive fracture. Diameter of metal which remained intact up to the time of final fracture, 3 inches.

That the type of failure was a progressive or detailed fracture, starting from one side of the axle and thence extending inward.

That final rupture occurred when there remained intact only about one-quarter of the original cross section of metal.

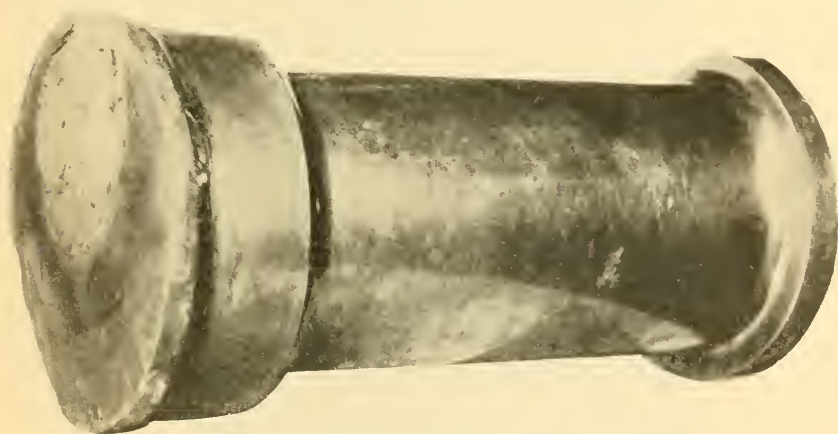
No. 8.—Portion of axle detached by plane of fracture at the wheel fit.

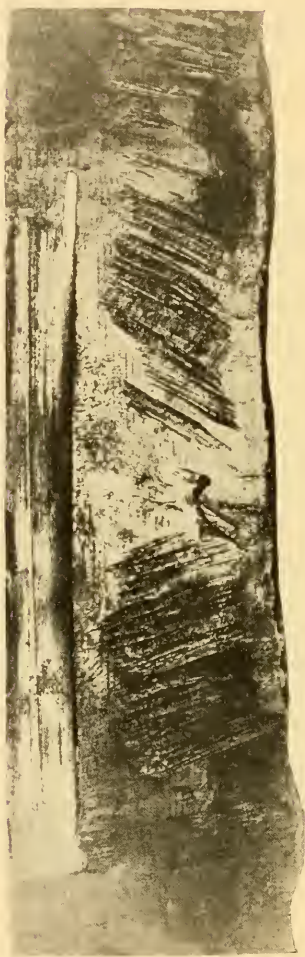
Upon dismantling the axle further evidence was disclosed which directed attention to this part of the wheel fit, namely, the serrations on the cylindrical surface, previously referred to, which were located near the place of rupture. Efforts were directed toward ascertaining why these serrations were present, which apparently attached to the period of machining the rough-turned forging or when pressing on

Conjecturally the most probable explanation for the cause of their presence, and when made, attaches to the time when the wheels were pressed on the axle. If, by accident, the axle was started askew when it first entered the hub of the wheel, the rapid action of the pump of the hydraulic press might cause damage to the wheel fit before its operation could be arrested. Provided this happened, the presence

of the sharp circumferential scoring would be consistently accounted for. Furthermore, the removal of the axle or its readjustment normal to the face of the hub would require unusual efforts, and hammering the axle to release it for readjustment is a plausible affair. The choice of tools available to do this is not very great in the vicinity of a wheel press, and such serrations might result from the use of some chance tool found near by.

No. 9.—Side view of axle at wheel fit, showing serrations on surface adjacent to plane of fracture. Fractured edge on the right of the cut. Microscopic specimens slotted off the left edge of this section.

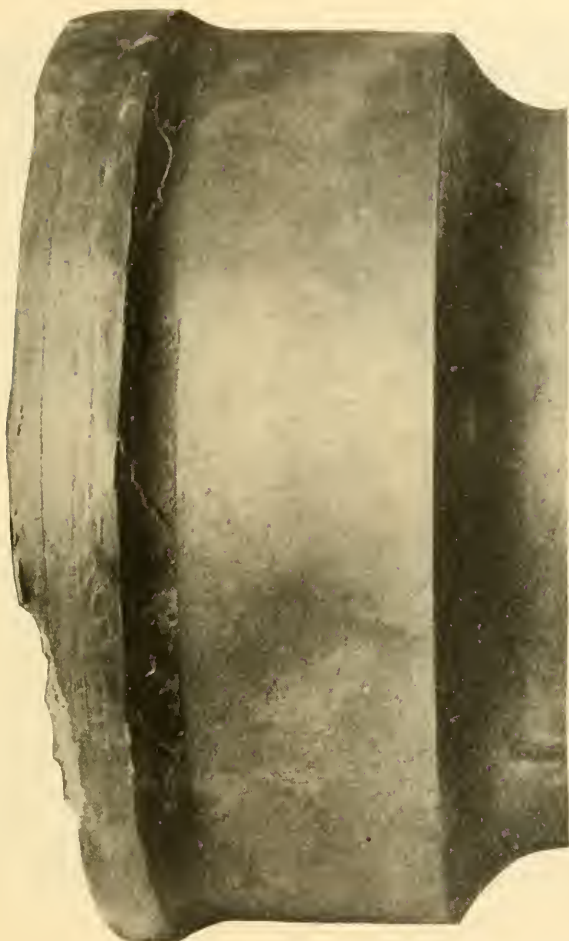
ure, and which was found in a well-defined circumferential mark scored upon the surface of the wheel fit, and which the plane of rupture followed over a considerable portion of its course. This scored line appeared to have located the incipient place of rupture. In appearance it resembled the effect of the cutting edge of some hard body rather than the mark of an ordinary lathe tool used in the finishing cut on the axle. If not made by a lathe tool, it must have been made by some hard body having substantially the

No. 10.—Side view of axle at wheel fit and dust guard, showing circumferential scoring on wheel fit, which the plane of fracture followed over a part of its course. Fractured edge on the left of the cut.

That the location of the place of rupture was probably influenced by circumferential scoring on the surface of the wheel fit, which the plane of rupture followed over a part of its course.

That the scoring was a defect of workmanship incident to the period of finishing the axle or when the wheel was being pressed on the end which subsequently fractured.

The axle failed prematurely, the only assignable cause for which is found in the surface defect on the wheel fit, to guard against the recurrence of which is a very obvious desideratum.

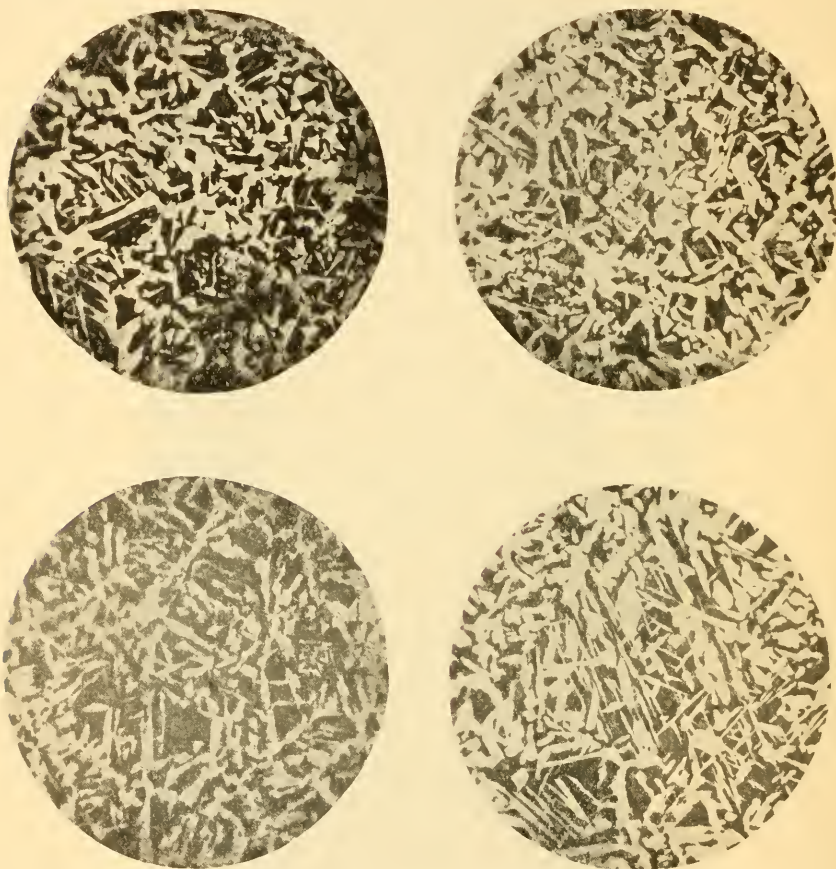
The metallographic examination, taken at four places on the circumference,  $90^\circ$  apart, showed identical structure throughout.

No. 11.—Microstructure of fractured axle near circumference at wheel fit and near place of fracture. Specimens taken out 90 degrees apart. Magnification, 50 diameters.
